BERRY RESERVOIR DAM
CT 00130

PHASE I INSPECTION REPORT
DAM INSPECTION PROGRAM

JANUARY 1980

4. TITLE (and Subtitle) Mulberry Reservoir Dam NATIONAL PROGRAM FOR INSPECTION OF NON-FEDERAL DAMS		5. TYPE OF REPORT & PERIOD COVERED INSPECTION REPORT

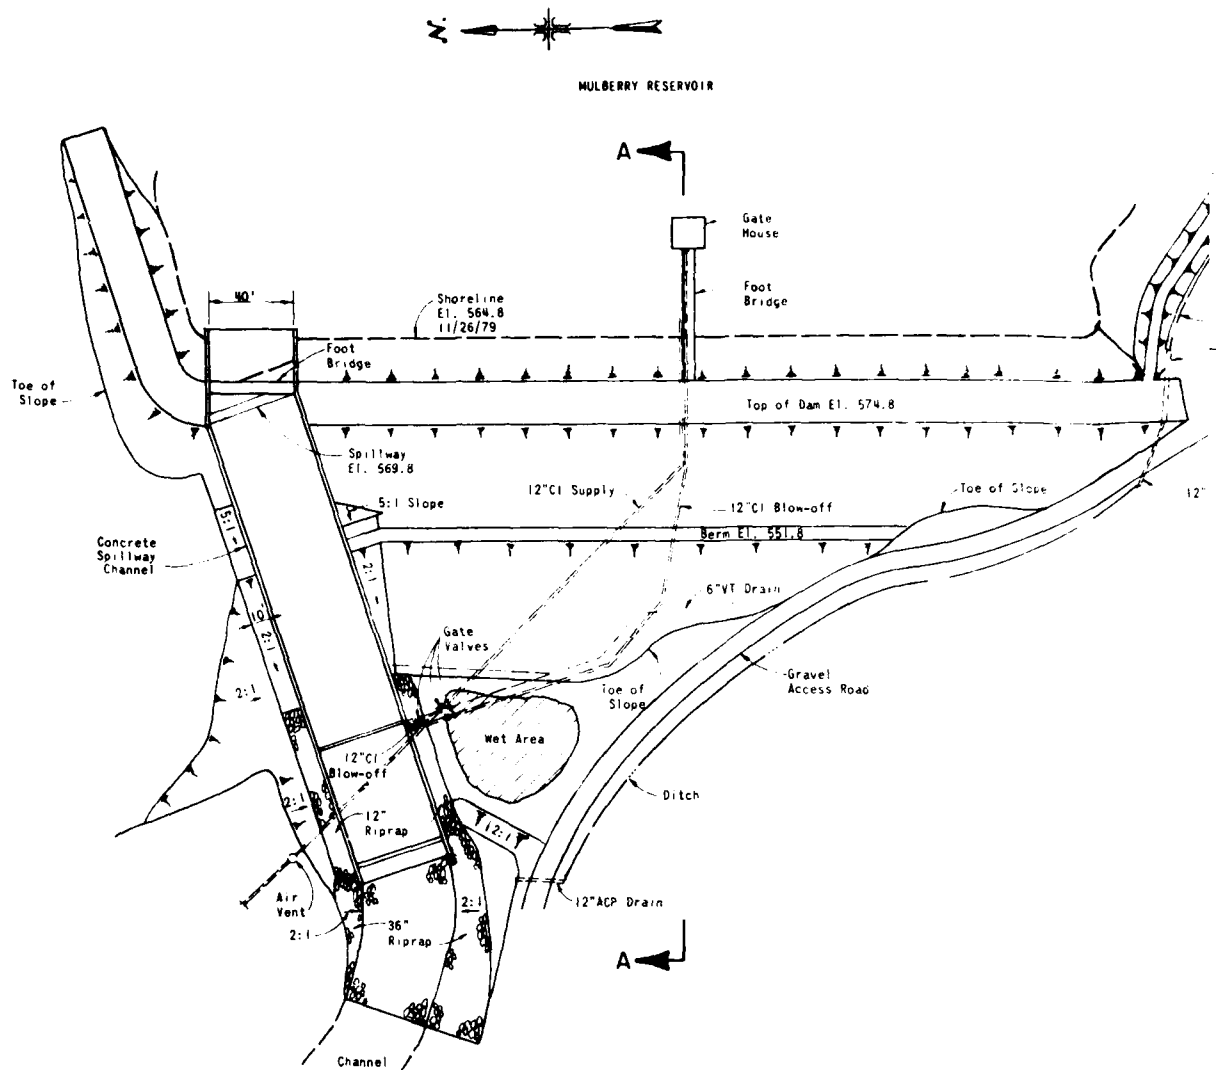
FIGURE 2

Field inspections and surveys revealed that the dam was constructed substantially as shown on the plans. The dike which forms a diversion channel and the pipe installed at the left end of the dam (See Figure 2, Appendix B) to divert an area of undesirable water quality away from the reservoir are not shown on the construction plans.

There are no indications of instability along the edges of the reservoir in the vicinity of the dam. At the left abutment a small dike forms a channel for diversion of a drainage area with poor water quality away from the reservoir and into a 24-inch pipe with an invert elevation of 571.2 or 1.4 feet above spillway level. The pipe passes through the dam and exits to the ditch on the left of the gravel access road as a 12-inch diameter pipe (See Figure 2, Appendix B).

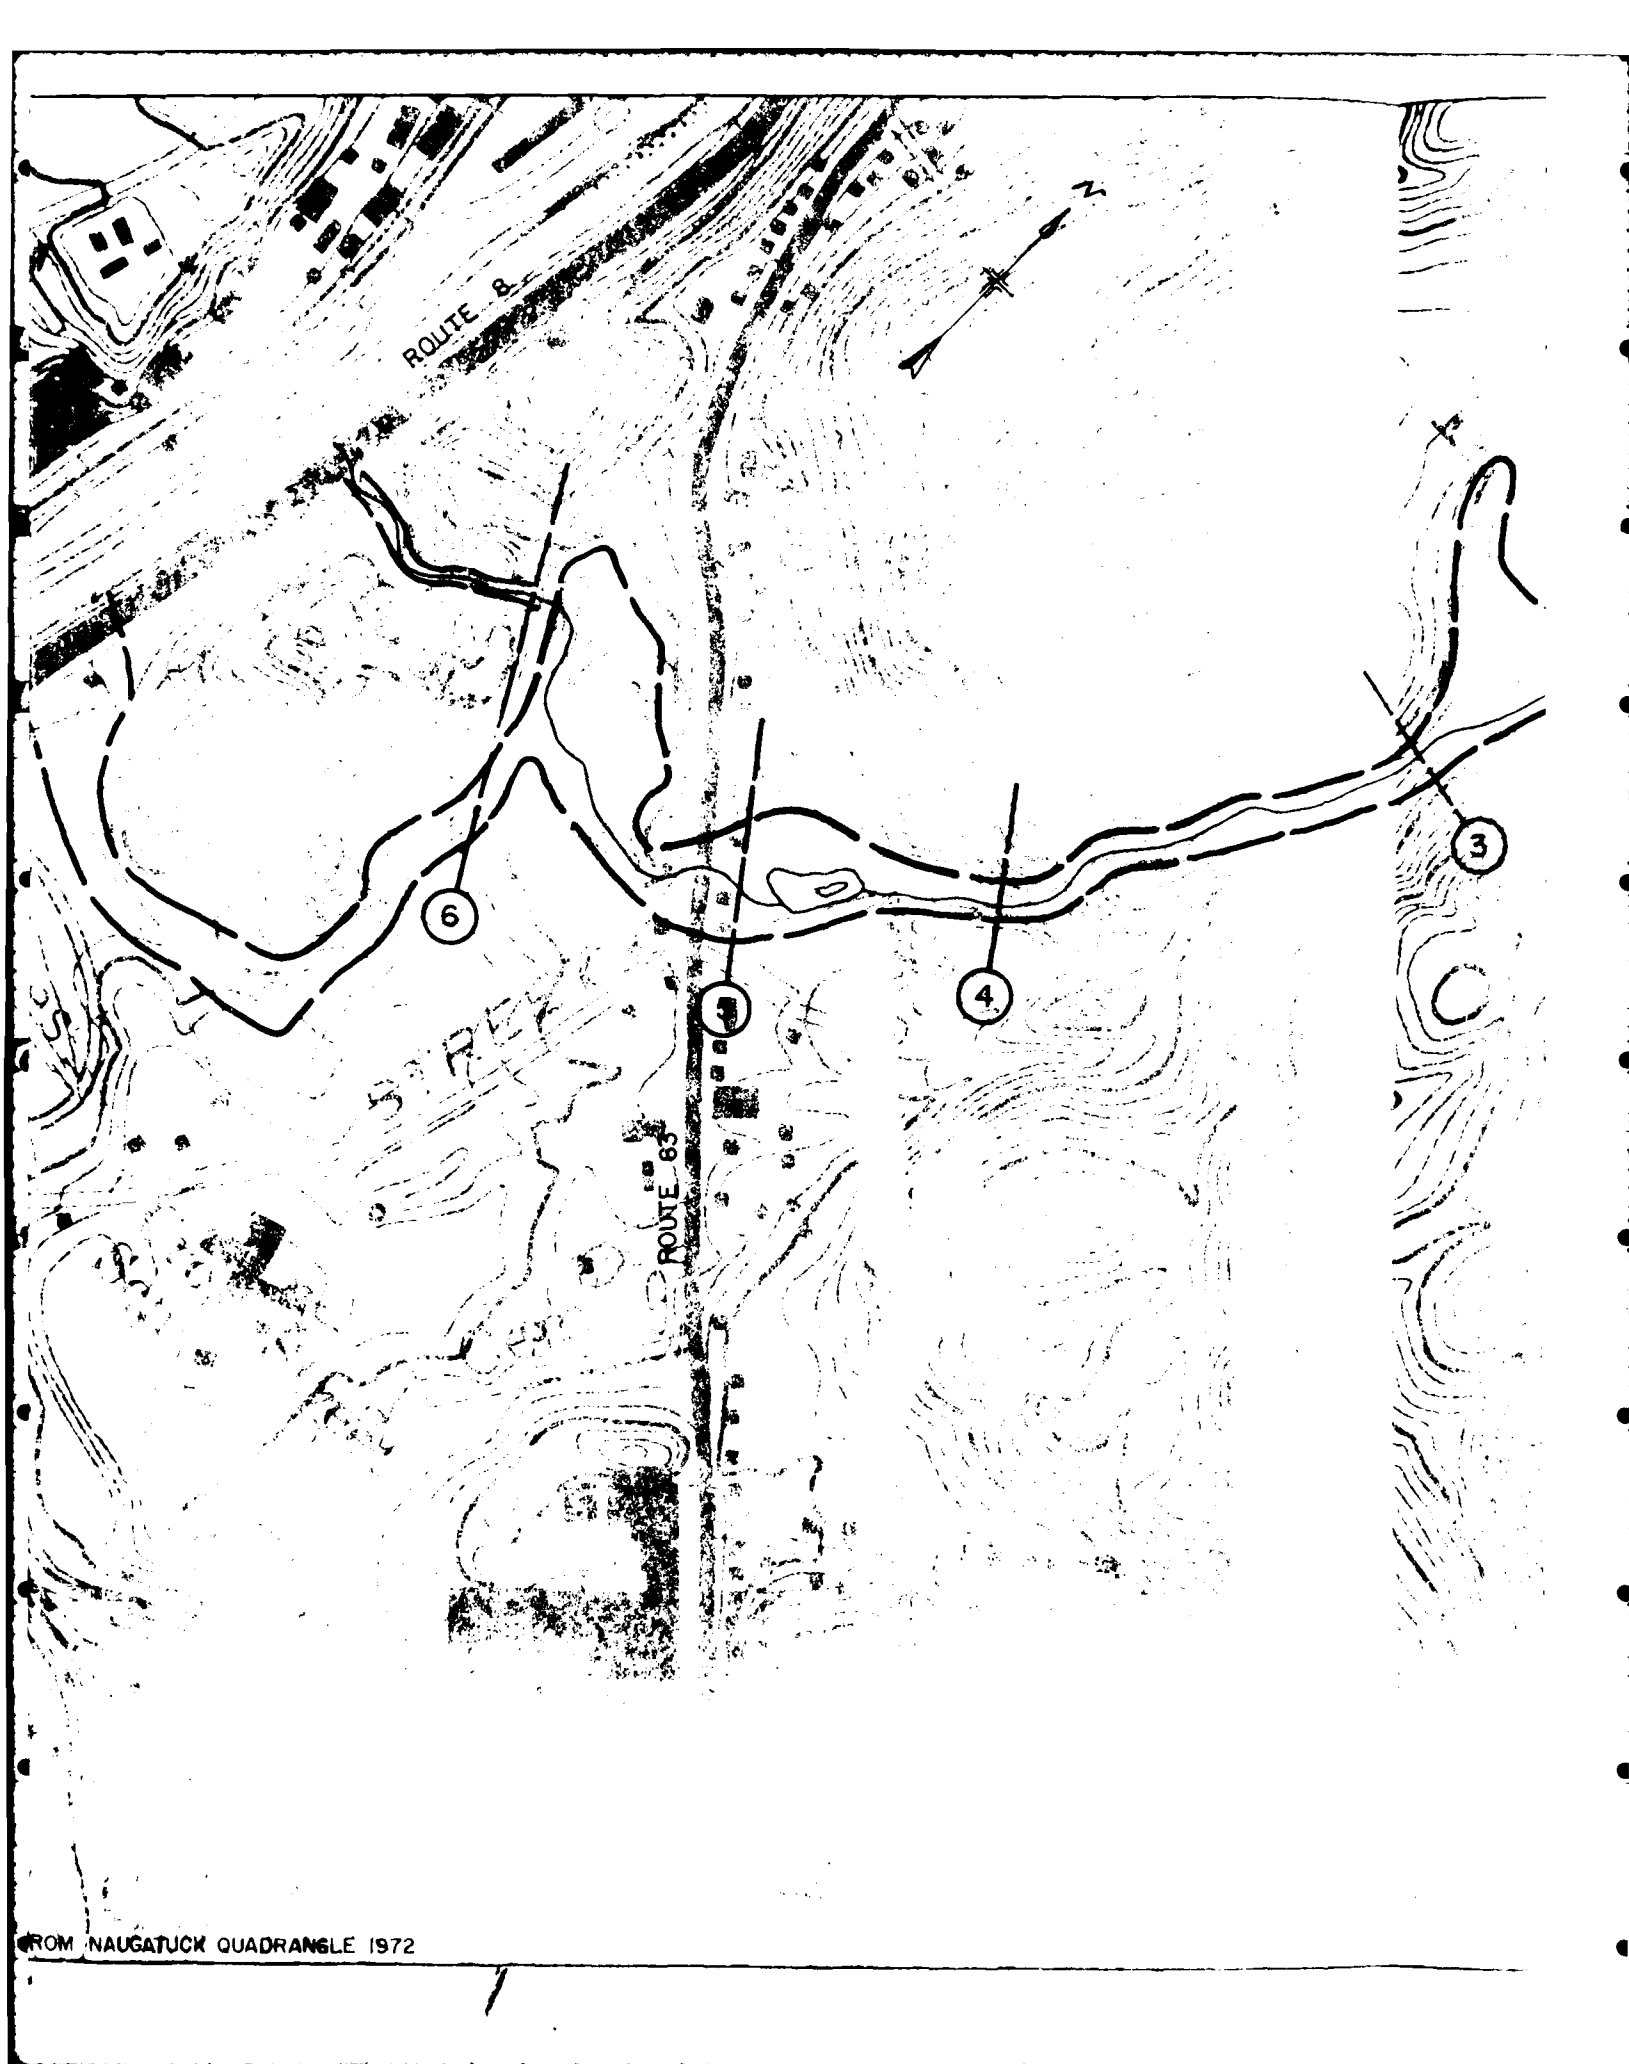
FIGURE 5

The flood areas resulting from a dam breach are shown on Figure 5 in Appendix D.
